Title  
**Sensor Installed In New Roofing In Insulation And Coverboard Installed**

NO-PUNCTURE ROOF DIAGNOSTICS INC

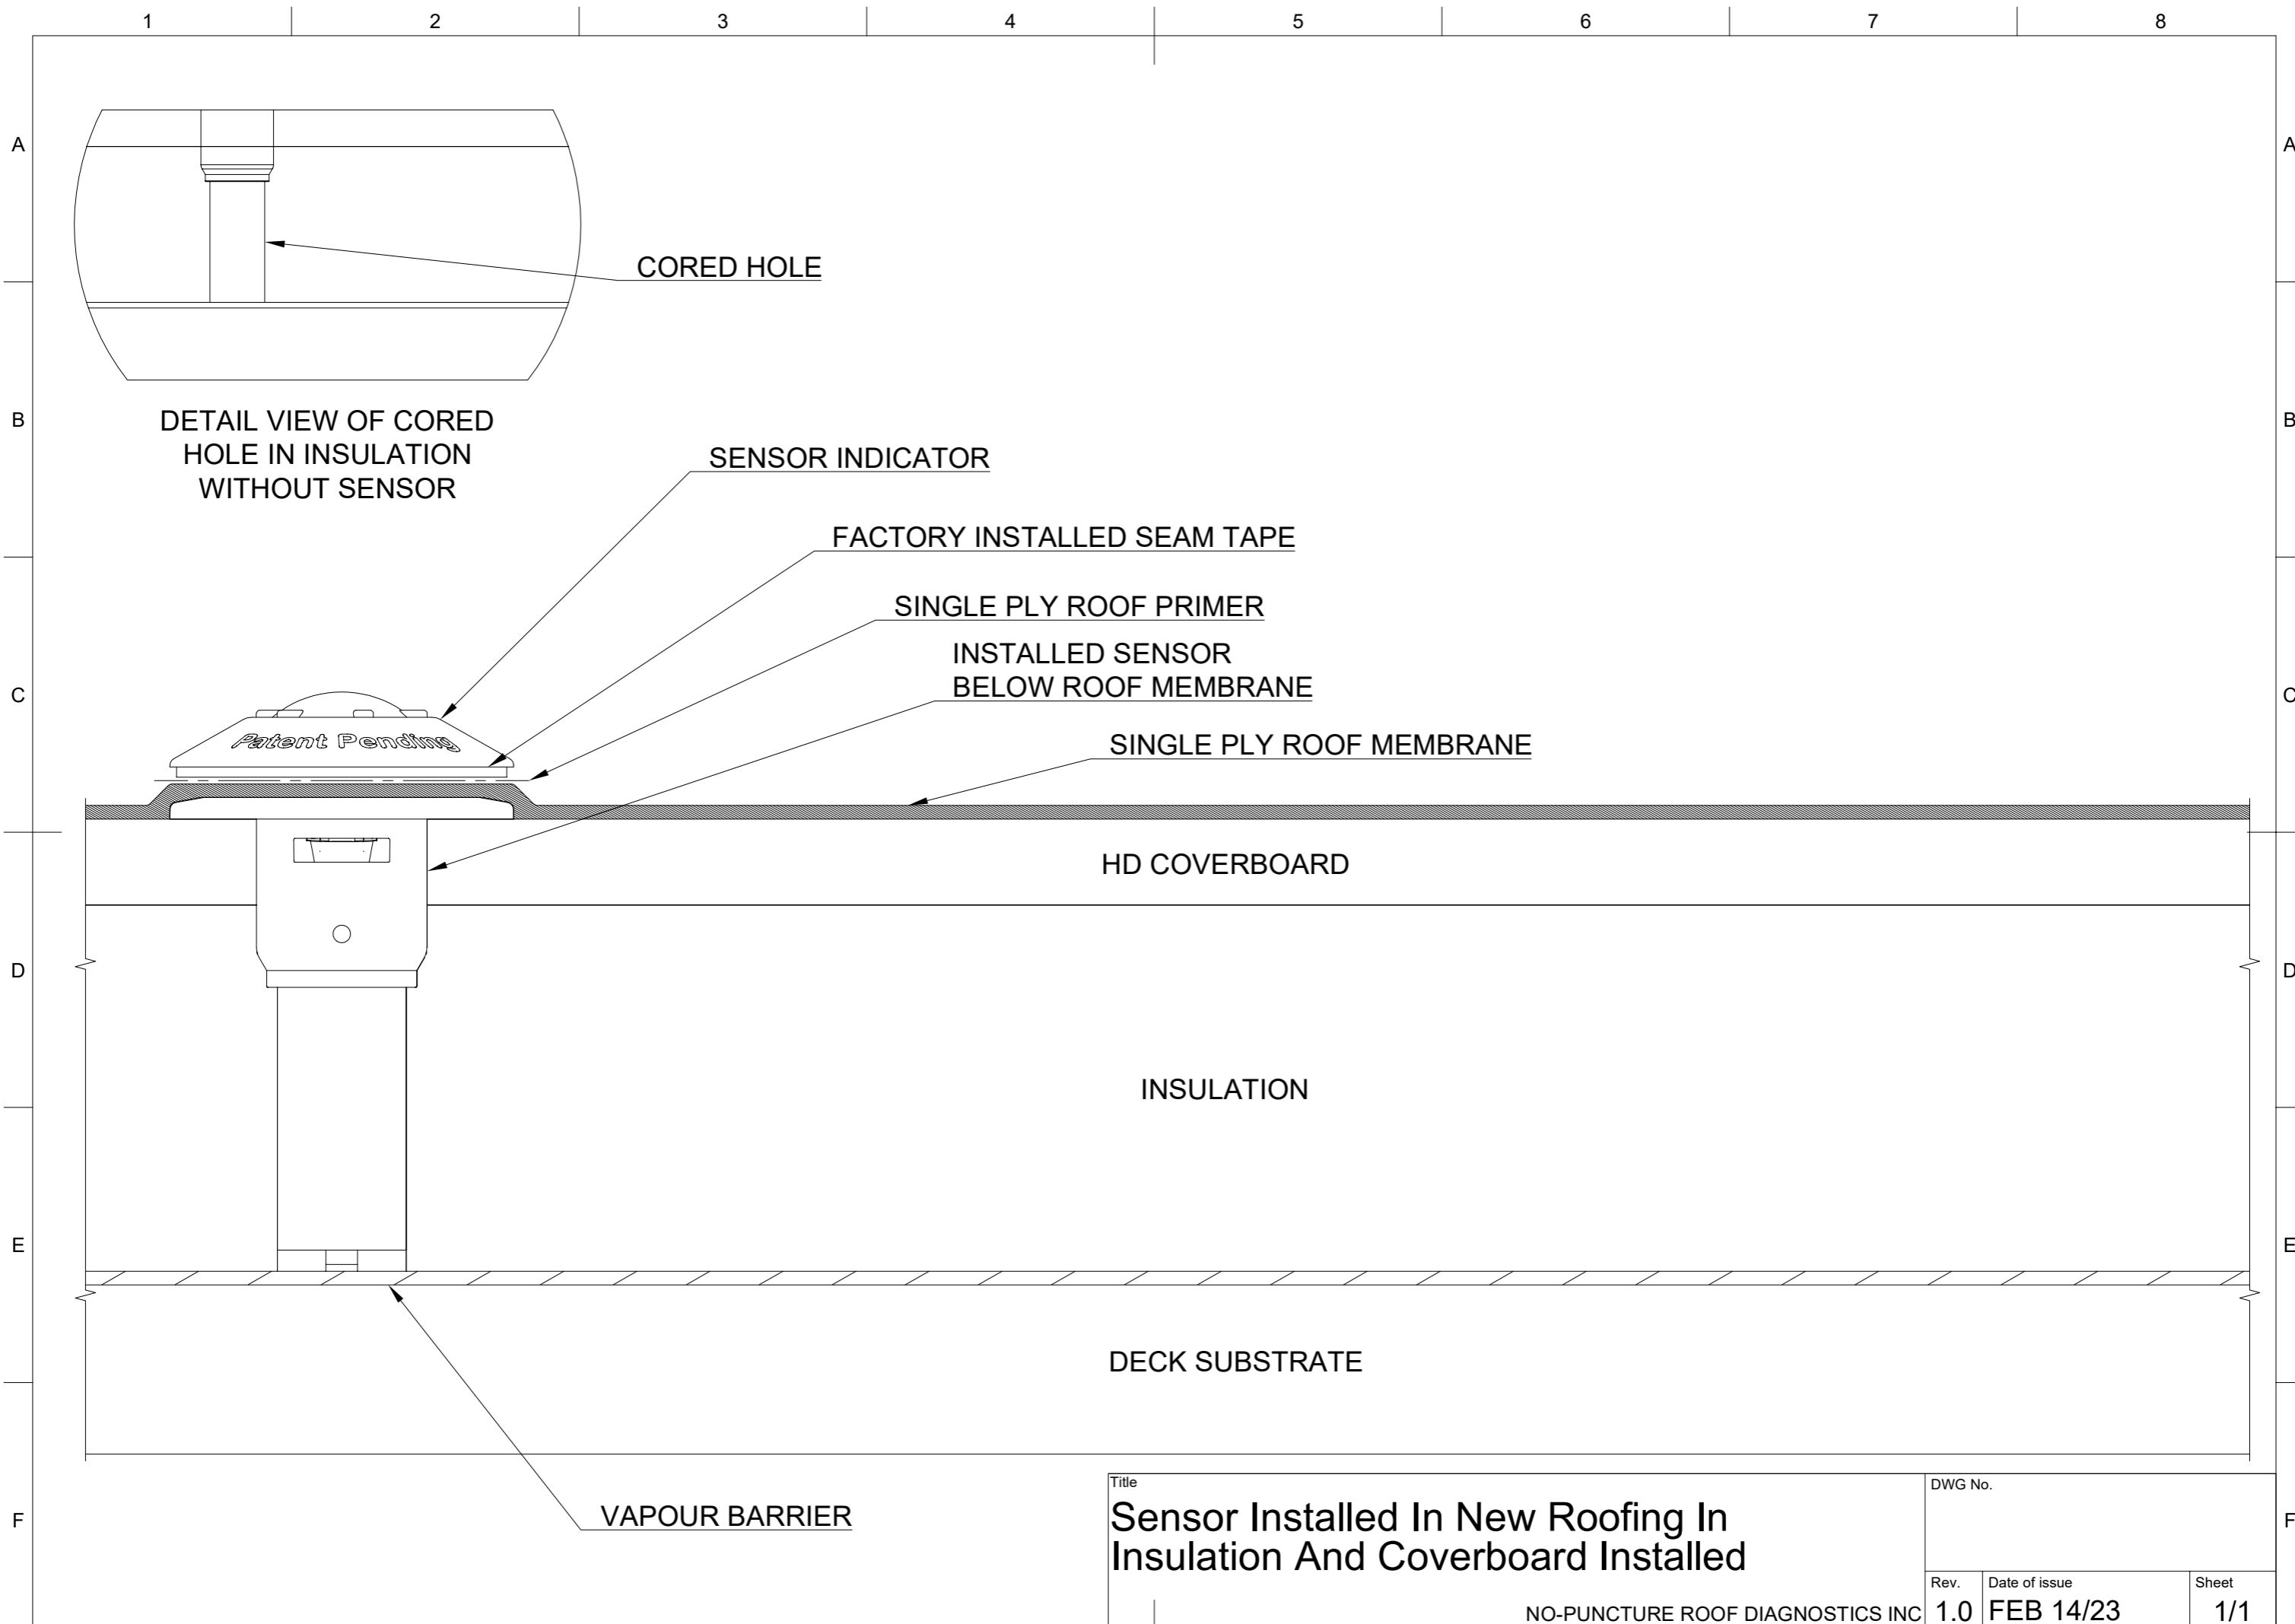
CORED HOLE

DETAIL VIEW OF CORED HOLE IN INSULATION WITHOUT SENSOR

SENSOR INDICATOR

FACTORY INSTALLED SEAM TAPE

SINGLE PLY ROOF PRIMER

INSTALLED SENSOR BELOW ROOF MEMBRANE

SINGLE PLY ROOF MEMBRANE

HD COVERBOARD

INSULATION

DECK SUBSTRATE

VAPOUR BARRIER
