Title  
**Sensor Installed In Re-Cover Roof System**

NO-PUNCTURE ROOF DIAGNOSTICS INC

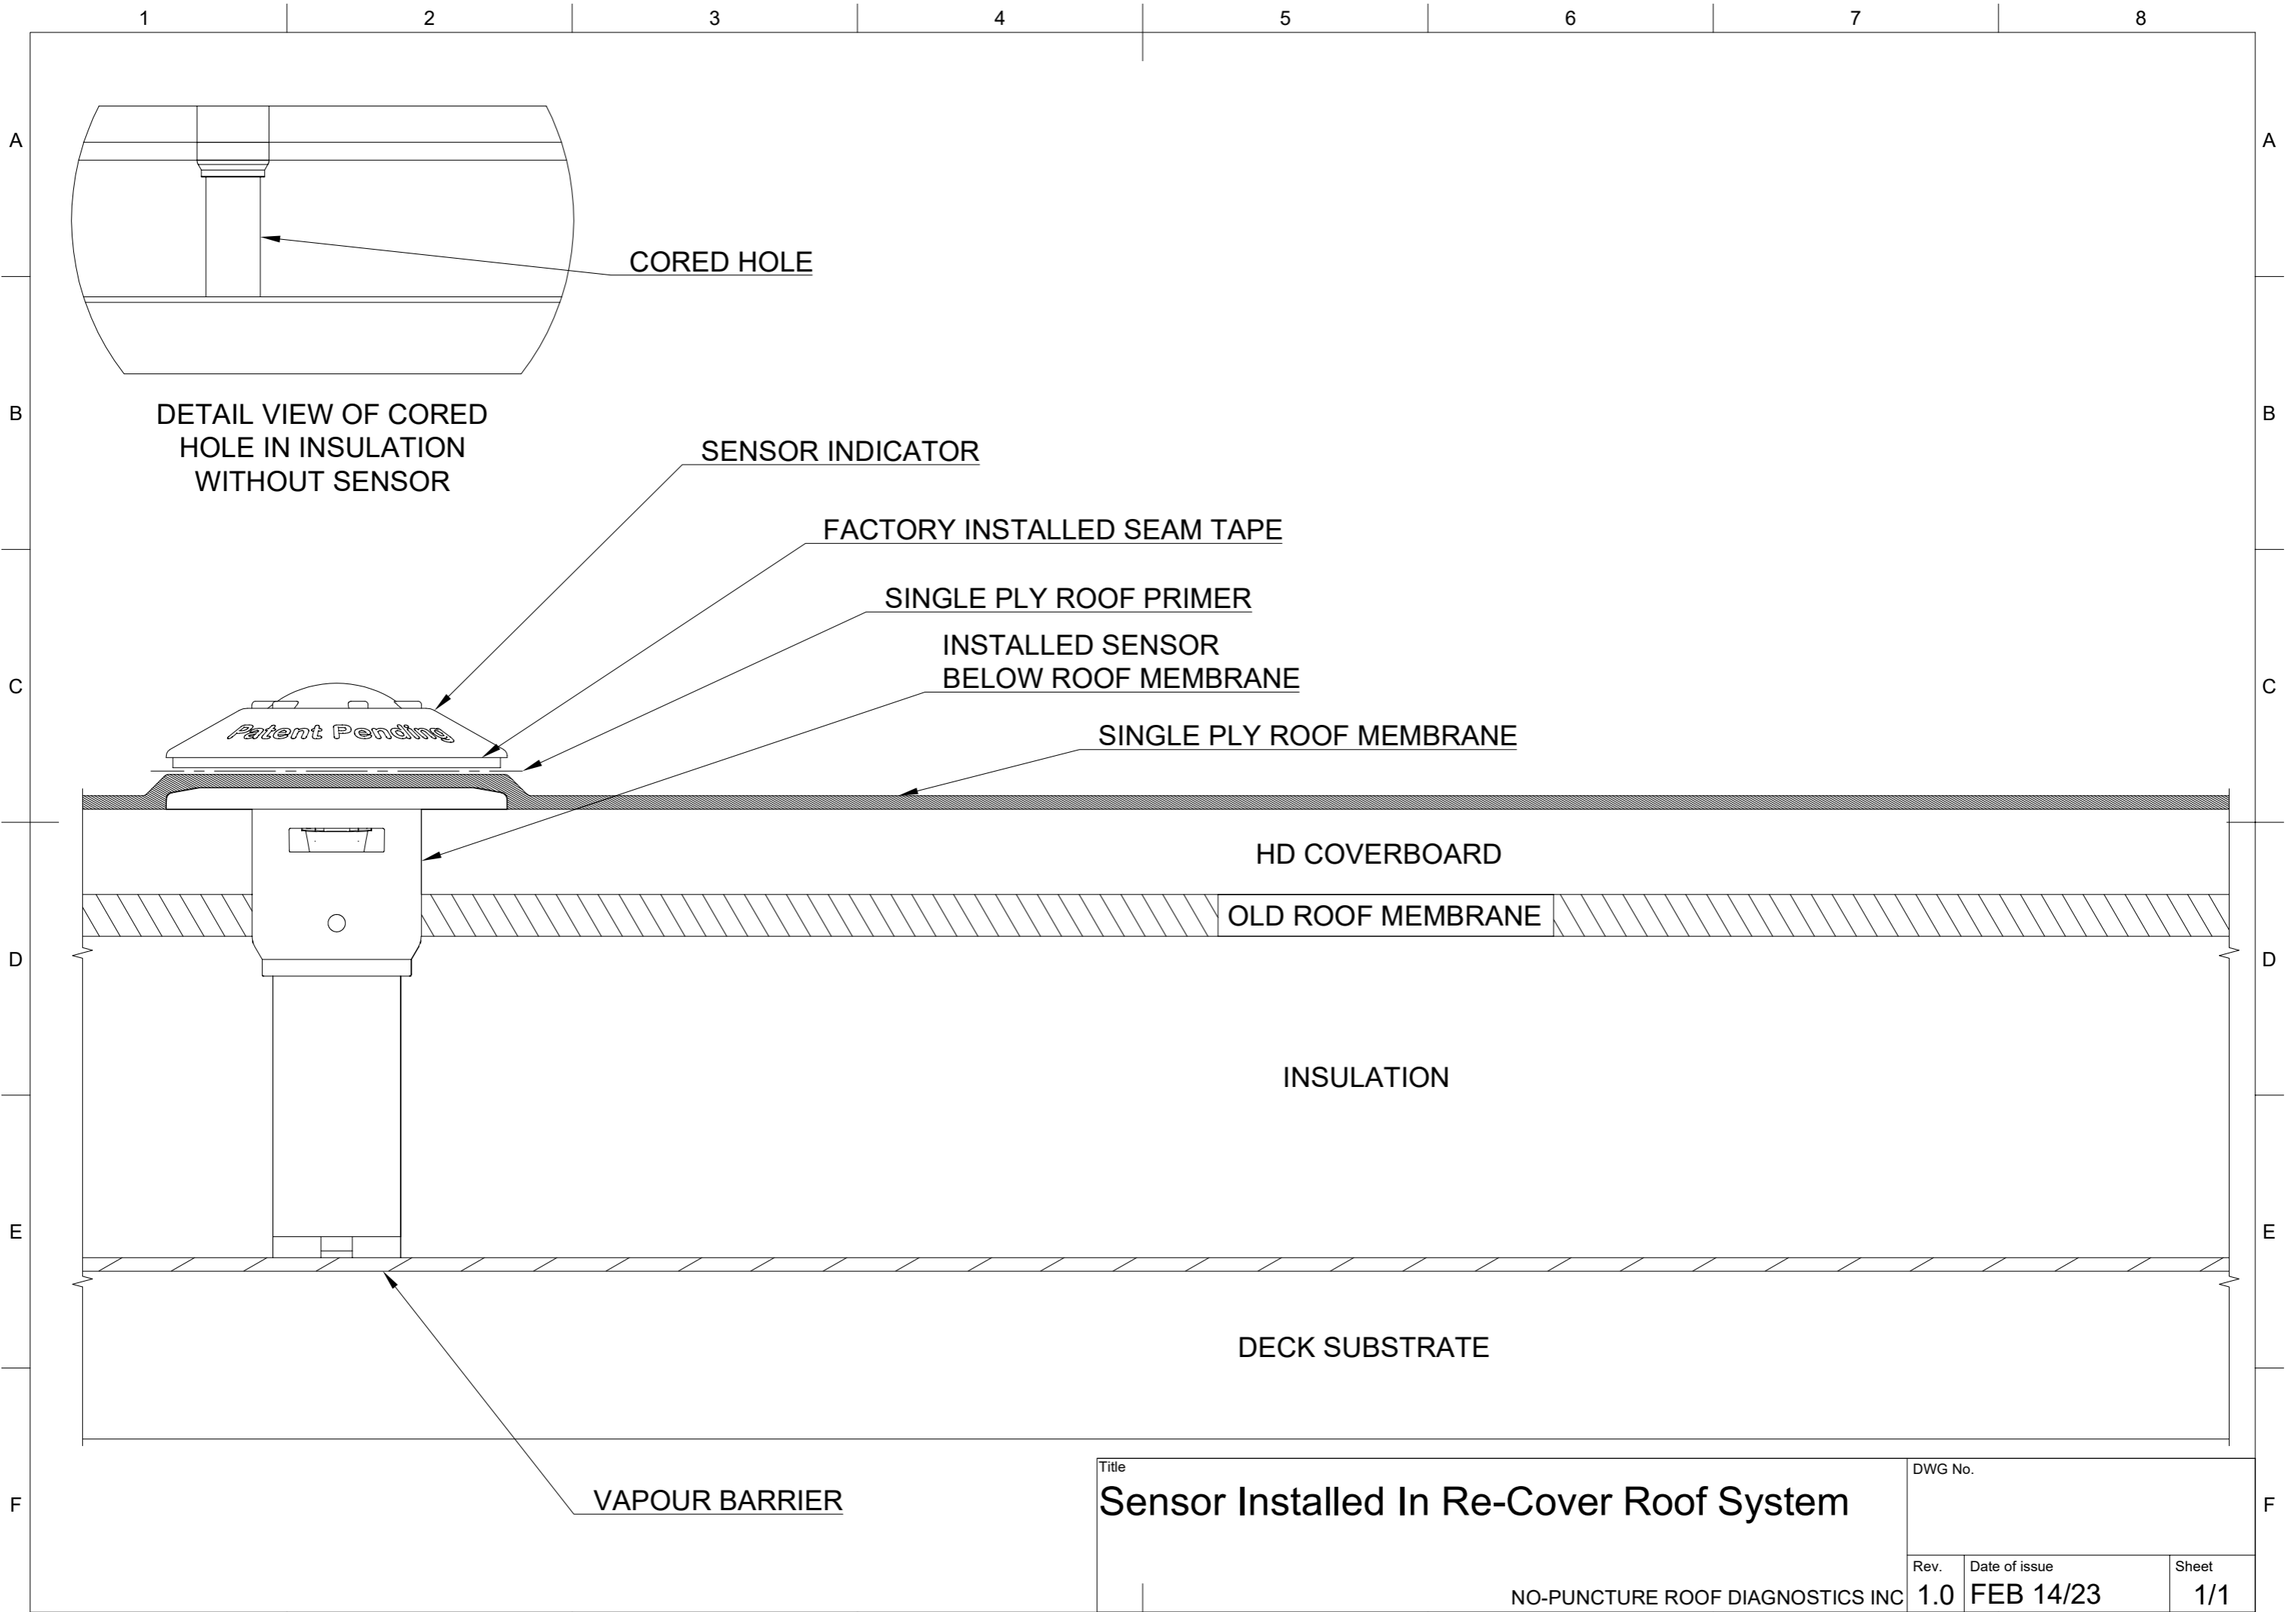
DETAIL VIEW OF CORED HOLE IN INSULATION WITHOUT SENSOR

CORED HOLE

SENSOR INDICATOR

FACTORY INSTALLED SEAM TAPE

SINGLE PLY ROOF PRIMER

INSTALLED SENSOR BELOW ROOF MEMBRANE

SINGLE PLY ROOF MEMBRANE

HD COVERBOARD

OLD ROOF MEMBRANE

INSULATION

DECK SUBSTRATE

VAPOUR BARRIER
